## Asbestos Register 19/10/2020

**Valley Gardens Middle**  
Valley Gardens  
Whitley Bay  
Tyne and Wear  
NE25 9AQ

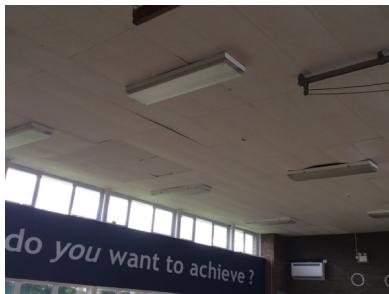
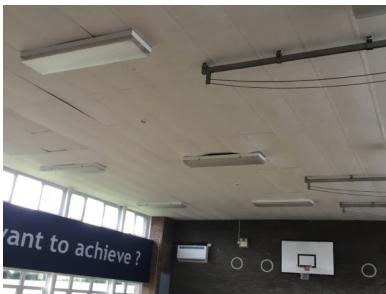
Location	Item
Item ID	J000616-048
Item Assessment	Limited Assessment Inaccessible Item
Reason for No Access	Unable to Sample due to Height Restriction
Property Name	Valley Gardens Middle
Area/floor	Ground floor
Room/location	Gym One
Specific location	Ceiling
Product/debris type	Acoustic Board Panels
Asbestos type	
Extent	0
Accessibility/vulnerability	
Additional information

Product Type (a)	N/A
Extent of Damage (b)	N/A
Surface Treatment (c)	N/A
Asbestos Fibre (d)	N/A
Total (a+b+c+d)	12
Material Risk Assessment	<span style="color: red;">■</span> High

Total (a+b+c+d+e+f+g+h)	12
Overall Risk Assessment	<span style="color: orange;">■</span> Low

Unable to sample/gain access due to height restriction further investigation required prior to disturbance

Action/recommendations	Further Investigation Required
------------------------	--------------------------------

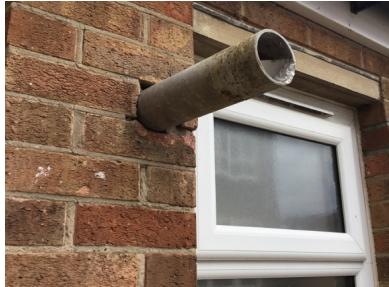
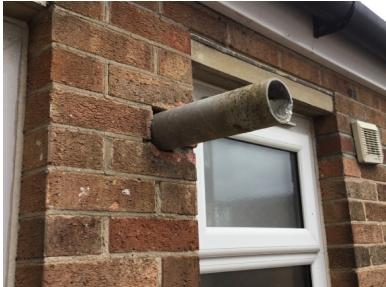
Location	Item
Item ID	003(OS)
Sample/link ID	S003
Property Name	Valley Gardens Middle
Area/floor	Ex
Room/location	Windows
Specific location	Wall
Product/debris type	Cement Product(s) Flue Pipe
Asbestos type	Identified Chrysotile
Extent	1 m
Accessibility/vulnerability	Low
Additional information	N/A
Licensed/non-licensed	N/A
R&D Element:	No
Air Test	-

Product Type (a)	1
Extent of Damage (b)	1
Surface Treatment (c)	1
Asbestos Fibre (d)	3
Total (a+b+c+d)	06
Material Risk Assessment	<span style="color: orange;">■</span> Low

Total (a+b+c+d+e+f+g+h)	11
Overall Risk Assessment	<span style="color: orange;">■</span> Low

Action/recommendations	Manage & Annually Re-inspect
------------------------	------------------------------

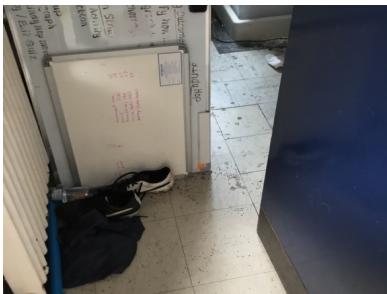
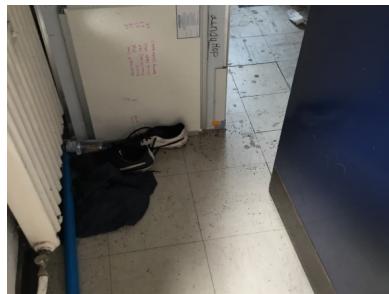
Location	Item
Item ID	010(OS)
Sample/link ID	S004
Property Name	Valley Gardens Middle
Area/floor	G
Room/location	G066
Specific location	Floor
Product/debris type	Flooring Floor Tile(s)
Asbestos type	Identified Chrysotile
Extent	4 m <sup>2</sup>
Accessibility/vulnerability	Medium
Additional information	N/A
Licensed/non-licensed	N/A
R&D Element:	No
Air Test	-

Product Type (a)	1
Extent of Damage (b)	1
Surface Treatment (c)	0
Asbestos Fibre (d)	1
Total (a+b+c+d)	03
Material Risk Assessment

Total (a+b+c+d+e+f+g+h) 09  
Overall Risk Assessment  Very Low

## Action/recommendations      Manage & Annually Re-inspect

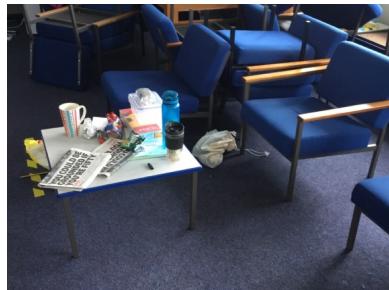
Location	Item
Item ID	012
Property Name	Valley Gardens Middle
Area/floor	1
Room/location	1007
Specific location	Floor
Product/debris type	Flooring Floor Tile(s)
Asbestos type	Identified Chrysotile
Extent	28 m <sup>2</sup>
Accessibility/vulnerability	Low
Additional information	N/A
Licensed/non-licensed	N/A
R&D Element:	No
Air Test	-

Product Type (a)	1
Extent of Damage (b)	1
Surface Treatment (c)	0
Asbestos Fibre (d)	1
Total (a+b+c+d)	03
Material Risk Assessment

Floor tiles not accessed as they are under a fixed carpet. Refer to the management survey recommendations.

Action/recommendations Manage & Annually Re-inspect

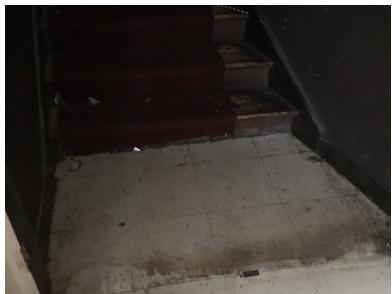
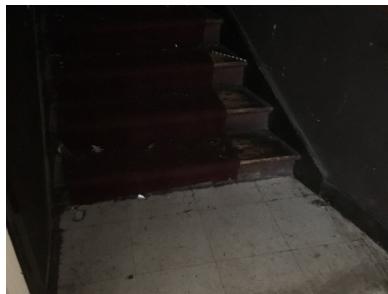
Location	Item
Item ID	001
Property Name	Valley Gardens Middle
Area/floor	G
Room/location	G005
Specific location	Floor
Product/debris type	Flooring Floor Tile(s)
Asbestos type	Identified Chrysotile
Extent	3 m <sup>2</sup>
Accessibility/vulnerability	Low
Additional information	N/A
Licensed/non-licensed	N/A
R&D Element:	No
Air Test	-

Product Type (a)	1
Extent of Damage (b)	1
Surface Treatment (c)	0
Asbestos Fibre (d)	1
Total (a+b+c+d)	03
Material Risk Assessment

Action/recommendations      Manage & Annually Re-inspect

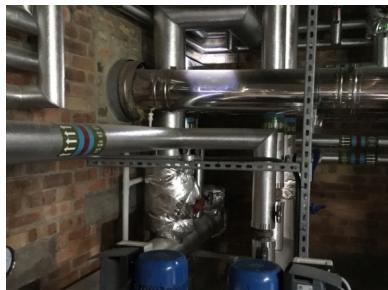
Location	Item
Item ID	020
Property Name	Valley Gardens Middle
Area/floor	E
Room/location	E001
Specific location	Pipework
Product/debris type	Gaskets To Pipe Work
Asbestos type	Presumed Crocidolite
Extent	10 Number
Accessibility/vulnerability	Very low
Additional information	N/A
Licensed/non-licensed	N/A
R&D Element:	No
Air Test	-

Product Type (a)	2
Extent of Damage (b)	1
Surface Treatment (c)	0
Asbestos Fibre (d)	3
Total (a+b+c+d)	06
Material Risk Assessment	■ Low

Total (a+b+c+d+e+f+g+h) 08  
Overall Risk Assessment  Very Low

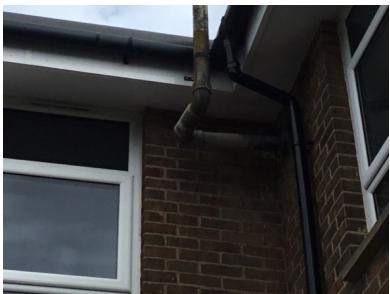
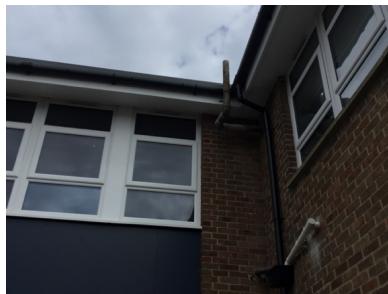
Item ID	024
Property Name	Valley Gardens Middle
Area/floor	E
Room/location	E005
Specific location	Wall
Product/debris type	Cement Product(s) Flue Pipe
Asbestos type	Identified Chrysotile
Extent	2 m
Accessibility/vulnerability	Very low
Additional information	N/A
Licensed/non-licensed	N/A
R&D Element:	No
Air Test	-

Product Type (a)	1
Extent of Damage (b)	1
Surface Treatment (c)	1
Asbestos Fibre (d)	1
Total (a+b+c+d)	04
Material Risk Assessment

Pipe runs into inaccessible cupboard. To North-West Elevation

Action/recommendations      Manage & Annually Re-inspect

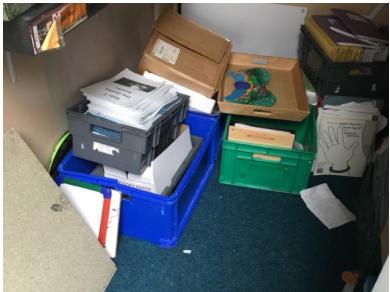
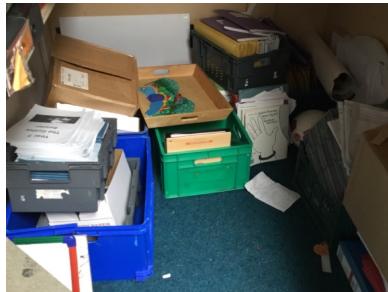
Item ID	007
Property Name	Valley Gardens Middle
Area/floor	G
Room/location	G045A
Specific location	Floor
Product/debris type	Flooring Floor Tile(s)
Asbestos type	Identified Chrysotile
Extent	3 m <sup>2</sup>
Accessibility/vulnerability	Medium
Additional information	N/A
Licensed/non-licensed	N/A
R&D Element:	No
Air Test	-

Product Type (a)	1
Extent of Damage (b)	1
Surface Treatment (c)	0
Asbestos Fibre (d)	1
Total (a+b+c+d)	03
Material Risk Assessment

Action/recommendations      Manage & Annually Re-inspect

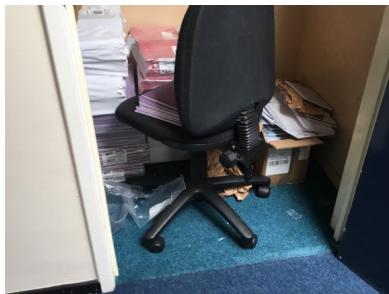
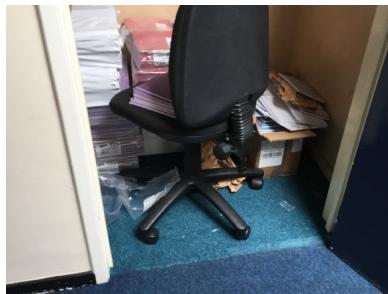
Location	Item
Item ID	008
Property Name	Valley Gardens Middle
Area/floor	G
Room/location	G046A
Specific location	Floor
Product/debris type	Flooring Floor Tile(s)
Asbestos type	Identified Chrysotile
Extent	2 m <sup>2</sup>
Accessibility/vulnerability	Low
Additional information	N/A
Licensed/non-licensed	N/A
R&D Element:	No
Air Test	-

Product Type (a)	1
Extent of Damage (b)	1
Surface Treatment (c)	0
Asbestos Fibre (d)	1
Total (a+b+c+d)	03
Material Risk Assessment

Action/recommendations      Manage & Annually Re-inspect

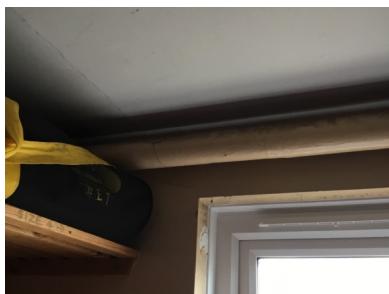
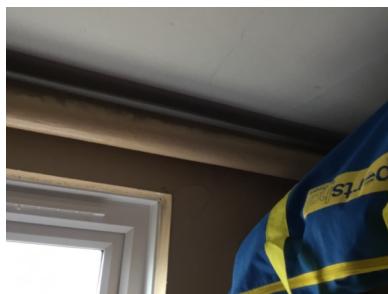
Location	Item
Item ID	J000616-043(OS)
Sample/link ID	J000616-043
Property Name	Valley Gardens Middle
Area/floor	Ground floor
Room/location	Room Seven
Specific location	Pipe Joint
Product/debris type	Paper
Asbestos type	Identified Chrysotile
Extent	4 m
Accessibility/vulnerability	
Additional information	
Licensed/non-licensed	N/A
R&D Element:	No
Air Test	-

Product Type (a)	1
Extent of Damage (b)	0
Surface Treatment (c)	2
Asbestos Fibre (d)	1
Total (a+b+c+d)	04
Material Risk Assessment

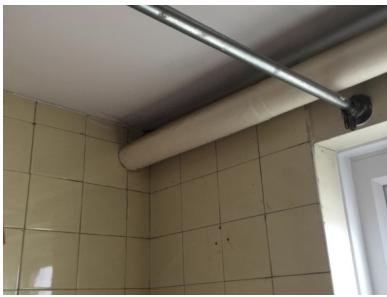
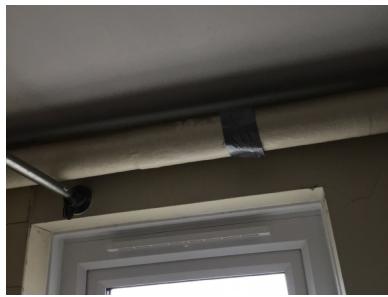
Location	Item
Item ID	J000616-056
Property Name	Valley Gardens Middle
Area/floor	Ground floor
Room/location	Room Eight
Specific location	Pipe Joint
Product/debris type	Tapes/webbing/woven Textile
Asbestos type	Strongly Presumed Chrysotile
Extent	16 m
Accessibility/vulnerability	
Additional information	
Licensed/non-licensed	N/A
R&D Element:	No
Air Test	-

Product Type (a)	1
Extent of Damage (b)	0
Surface Treatment (c)	2
Asbestos Fibre (d)	1
Total (a+b+c+d)	04
Material Risk Assessment

Friable edge to paper lined pipe work

Action/recommendations Encapsulate under PCC by FLC

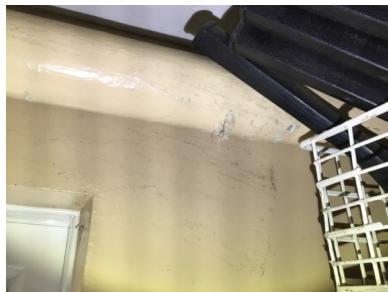
Location	Item
Item ID	J000616-055
Property Name	Valley Gardens Middle
Area/floor	Ground floor
Room/location	Room Six
Specific location	Pipe Joint
Product/debris type	paper
Asbestos type	Strongly Presumed Chrysotile
Extent	16 m
Accessibility/vulnerability	
Additional information	
Licensed/non-licensed	N/A
R&D Element:	No
Air Test	-

Product Type (a)	1
Extent of Damage (b)	0
Surface Treatment (c)	2
Asbestos Fibre (d)	1
Total (a+b+c+d)	04
Material Risk Assessment

Recommend moving PE equipment away from asbestos material to avoid unnecessary damage to textile on pipe

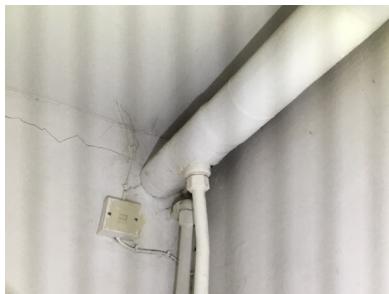
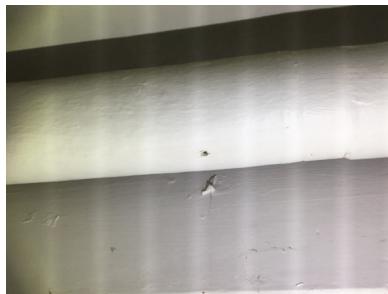
Location	Item
Item ID	J000616-054
Property Name	Valley Gardens Middle
Area/floor	Ground floor
Room/location	Room Five
Specific location	Pipe Joint
Product/debris type	Paper
Asbestos type	Strongly Presumed Chrysotile
Extent	16 m
Accessibility/vulnerability	
Additional information	
Licensed/non-licensed	N/A
R&D Element:	No
Air Test	-

Product Type (a)	1
Extent of Damage (b)	0
Surface Treatment (c)	2
Asbestos Fibre (d)	1
Total (a+b+c+d)	04
Material Risk Assessment	<span style="color: yellow;">Very Low</span>

Action/recommendations	Repair Damaged Area
------------------------	---------------------

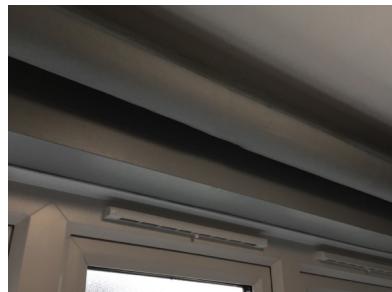
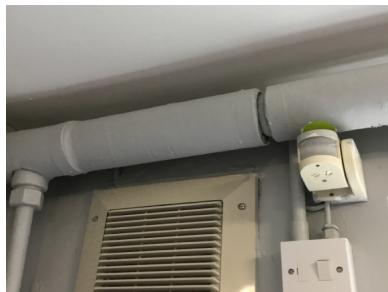
Location	Item
Item ID	J000616-044
Property Name	Valley Gardens Middle
Area/floor	Ground floor
Room/location	Room Three
Specific location	Pipe Joint
Product/debris type	Paper
Asbestos type	Strongly Presumed Chrysotile
Extent	16 m
Accessibility/vulnerability	
Additional information	
Licensed/non-licensed	N/A
R&D Element:	No
Air Test	-

Product Type (a)	1
Extent of Damage (b)	0
Surface Treatment (c)	2
Asbestos Fibre (d)	1
Total (a+b+c+d)	04
Material Risk Assessment	<span style="color: yellow;">Very Low</span>

Action/recommendations	Manage & Annually Re-inspect
------------------------	------------------------------

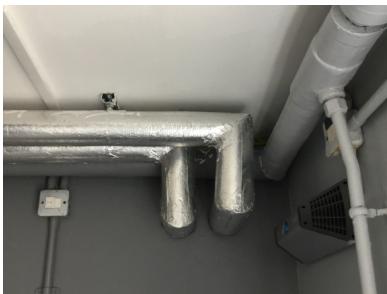
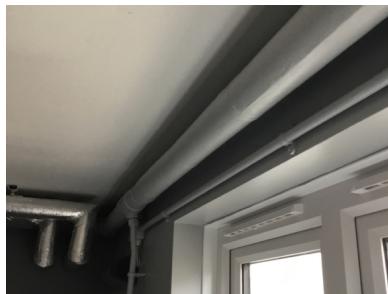
Location	Item
Item ID	J000616-053
Property Name	Valley Gardens Middle
Area/floor	Ground floor
Room/location	Room Four
Specific location	Pipe Joint
Product/debris type	Paper/felt/cardboard Paper Lining to Pipework
Asbestos type	Strongly Presumed Chrysotile
Extent	16 m
Accessibility/vulnerability	
Additional information	
Licensed/non-licensed	N/A
R&D Element:	No
Air Test	-

Product Type (a)	2
Extent of Damage (b)	0
Surface Treatment (c)	1
Asbestos Fibre (d)	1
Total (a+b+c+d)	04
Material Risk Assessment

Action/recommendations      Manage & Annually Re-inspect

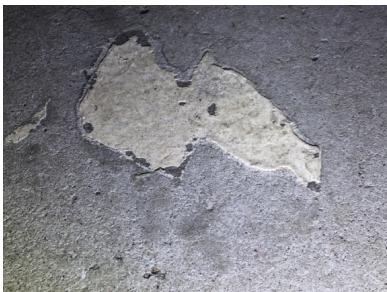
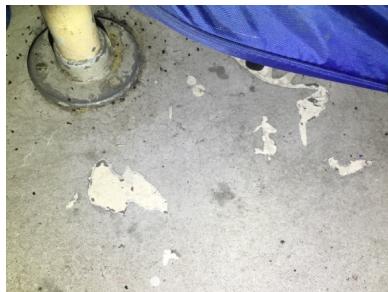
Location	Item
Item ID	J000616-042
Property Name	Valley Gardens Middle
Area/floor	Ground floor
Room/location	Room Seven
Specific location	Floor
Product/debris type	Vinyl remnants
Asbestos type	Strongly Presumed Chrysotile
Extent	6 m <sup>2</sup>
Accessibility/vulnerability	Low
Additional information	
Licensed/non-licensed	N/A
R&D Element:	No
Air Test	-

Product Type (a)	1
Extent of Damage (b)	1
Surface Treatment (c)	0
Asbestos Fibre (d)	1
Total (a+b+c+d)	03
Material Risk Assessment

Action/recommendations      Manage & Annually Re-inspect

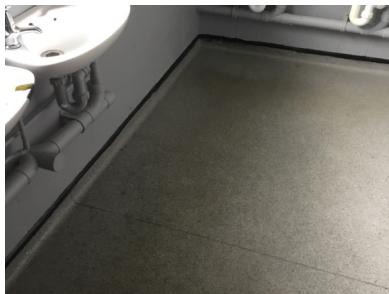
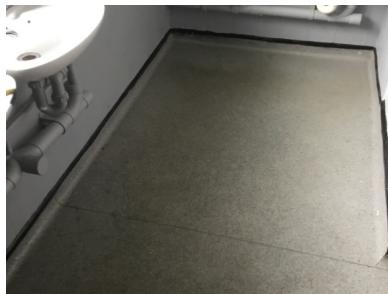
Location	Item
Item ID	J000616-058
Property Name	Valley Gardens Middle
Area/floor	Ground floor
Room/location	Room Four
Specific location	Floor
Product/debris type	Vinyl
Asbestos type	Strongly Presumed Chrysotile
Extent	6 m <sup>2</sup>
Accessibility/vulnerability	Low
Additional information	
Licensed/non-licensed	N/A
R&D Element:	No
Air Test	-

Product Type (a)	1
Extent of Damage (b)	1
Surface Treatment (c)	0
Asbestos Fibre (d)	1
Total (a+b+c+d)	03
Material Risk Assessment

Top layer of vinyl appears modern, presume older type is present beneath

## Action/recommendations      Manage & Annually Re-inspect

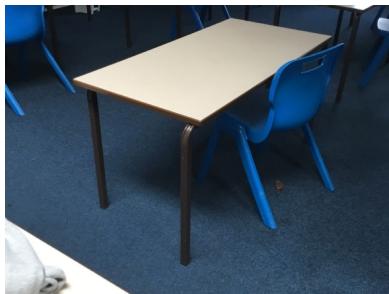
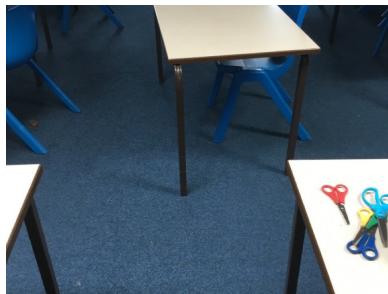
Location	Item
Item ID	J000616-017(OS)
Sample/link ID	J000616-017
Property Name	Valley Gardens Middle
Area/floor	Ground floor
Room/location	G046
Specific location	Other Store floor
Product/debris type	Vinyl
Asbestos type	Identified Chrysotile
Extent	4 m <sup>2</sup>
Accessibility/vulnerability	Low
Additional information	
Licensed/non-licensed	N/A
R&D Element:	No
Air Test	-

Product Type (a)	1
Extent of Damage (b)	1
Surface Treatment (c)	0
Asbestos Fibre (d)	1
Total (a+b+c+d)	03
Material Risk Assessment

Chrysotile in both tile and adhesive.

Action/recommendations      Manage & Annually Re-inspect
